**Flood Control Project Maintenance
Levee Inspections**

Maintenance Issue Types Only, Levee Inspection Report By Mile - Fall 2018

Reclamation District No. 2096 Wetherbee Lake

Waterway	Bank	Unit Miles	Inspection Start/End	Inspector
Unit No. 01 San Joaquin River	Right	0.16	11/09/2018 11/09/2018	Richard Willoughby

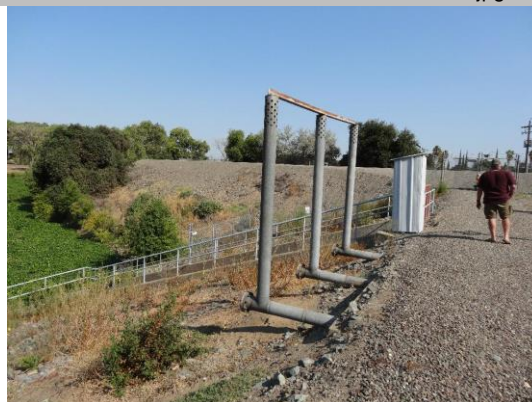
Photo 2 of 3 : UCIP_FA_2018_21505_36448.jpg

WS view: three air vents for three drainage pipes on levee shoulder.

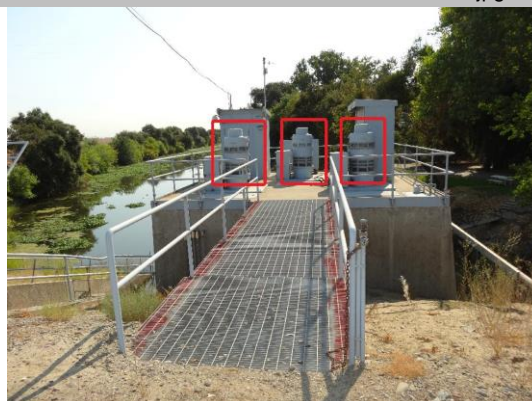
Photo 3 of 3 : UCIP_FA_2018_21505_36447.jpg

LS view: automatic pumping plant with three pumps. Steel walkway to pump platform.

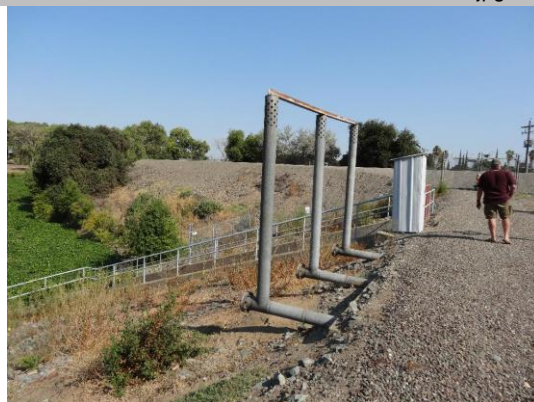
Photo 2 of 3 : UCIP_FA_2018_21507_36455.jpg

WS view: three air vents for three drainage pipes on levee shoulder.

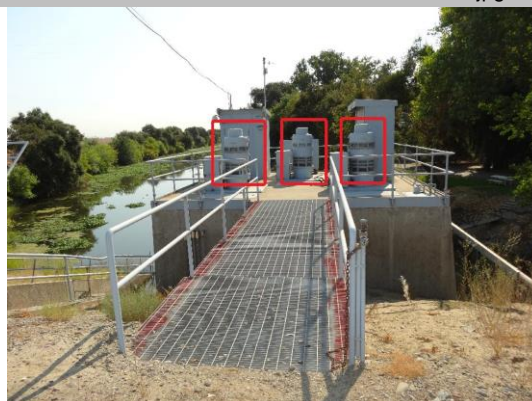
Photo 3 of 3 : UCIP_FA_2018_21507_36454.jpg

LS view: automatic pumping plant with three pumps. Steel walkway to pump platform.

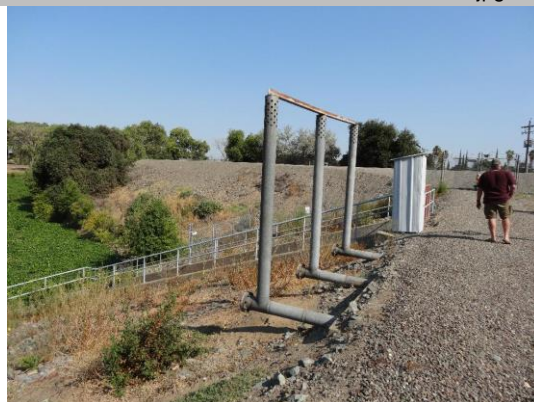
Photo 2 of 3 : UCIP_FA_2018_21508_36460.jpg

WS view: three air vents for three drainage pipes on levee shoulder.

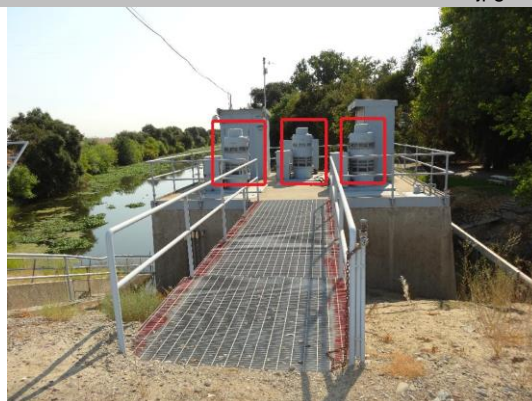
Photo 3 of 3 : UCIP_FA_2018_21508_36461.jpg

LS view: automatic pumping plant with three pumps. Steel walkway to pump platform.

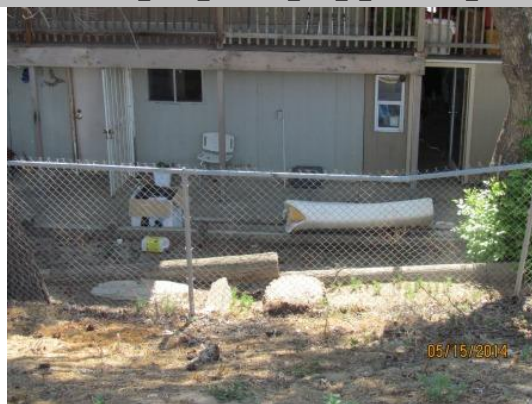
Photo 1 of 1 : FA_2018_RD2096_117_9_20180906_00003.jpg

LM Start	0.06	Rating **	N	Issue No.	9
LM End	0.06	Issue Type +	Ma	Location *	LS
Category	Earthen Levee			GPS Latitude/Longitude	
				Start	End
Item	Trim / Thin Trees			37.773348 °	37.773348 °
				-121.298475 °	-121.298475 °
DWR ID	DWR_RD2096_01_s_2014_9				
Comment Code					
T5 : Tree stumps.					
Inspector Comment					
Pine tree stump at levee toe.

View of the tree stump at the landside levee toe.

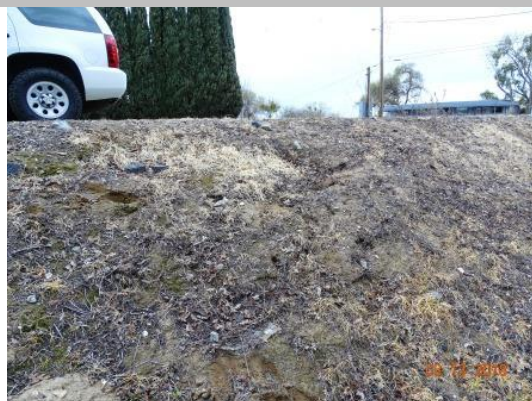
Photo 1 of 1 : FA_2018_RD2096_117_6_20180906_00001.jpg

LM Start	0.09	Rating **	A/W	Issue No.	6
LM End	0.09	Issue Type +	Ma	Location *	LS
Category	Earthen Levee			GPS Latitude/Longitude	
				Start	End
Item	Animal Control			37.772891°	37.772891°
				-121.298454°	-121.298454°
DWR ID	DWR_RD2096_01_s_2016_6				
Comment Code					
A3 : No rodents visible, but rodent burrows visible; need to backfill and compact or grout burrows.					
Inspector Comment					
LMA has effective rodent control program. Monitor this location for possible future activity.

View of the previously rodent infested area on the landside levee slope.

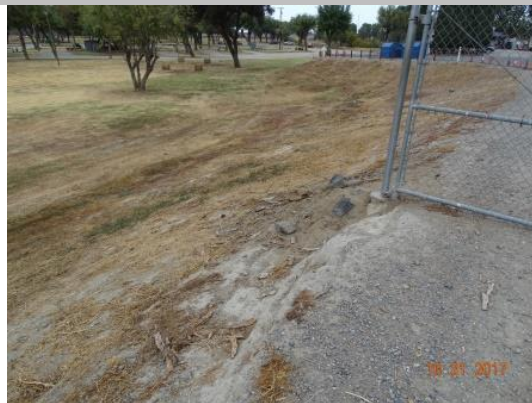
Photo 2 of 3 : FA_2018_RD2096_117_11_20180906_00005.jpg

Another view of the material placed to prevent vehicles from driving around the gate. Looking downstream.

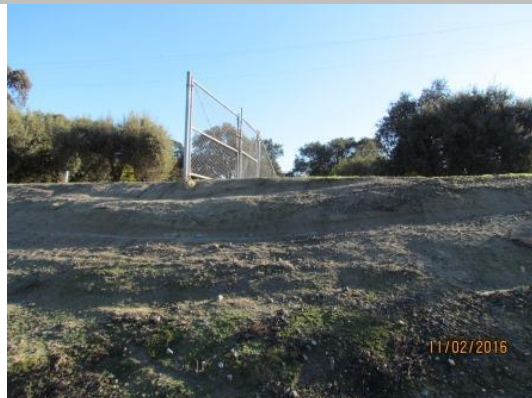
Photo 3 of 3 : FA_2018_RD2096_117_11_20180906_00006.jpg

LM Start	0.12	Rating **	M	Issue No.	11 (cont)	
LM End	0.12	Issue Type +	Ma	Location *	WS	
Category	Earthen Levee			GPS Latitude/Longitude		
				Start		End
Item	Slope Stability			37.772434 °		37.772434 °
				-121.298433 °		-121.298433 °
DWR ID	DWR_RD2096_01_s_2015_11					
Comment Code						
S3 : Repair the levee slope damaged by vehicle traffic and prevent access where possible.						
Inspector Comment						
LMA restricted access but still a regrade and re-compaction of damaged waterside levee slope is required.

View of the waterside slope damaged by vehicle.
